Service Bulletin			
PRODUCT:	Refrigerator		
TIP NUMBER:		ASC20050415001	
TIP DATE:	04/15/2005		
MODELS:	RS2577 RS2644 RS2666 RS2533 RS2533 RS2534 RS2534 RS2534 RS2534 RS2531 RS2531 RS2531	8SW,RS2555SW,RS2555SL, 7SW, RS2577SL,RS2555SL 7SL,RS2544SL,RS2622SW, 4SW, RS2777SL,RS2644SL 6SW,RS2666SL,RS2777SL, 4SW RS2755BGT,RS2520SW 8VQ,RS2555VQ,RS2577VQ, 8BB, RS2555BB,RS2577BB 4WW,RS2556WW,RS2578WW, 4VQ, RS2556BB,RS2556SH 8BB,RS2578SH, RS2556SW/XAA 4BB, RS2542SH, RS2545SH 8AWW,RS255BAWW,RS253BAWW 8AVQ, RS253BABB, RS253BASB 8ABB, RS255BASB, RS257BASB 8AWW, RS257BABB, RS257BARB

SUBJECT: Capillary tube is not inserted to the dryer correctly this creates a Low or No Cool condition

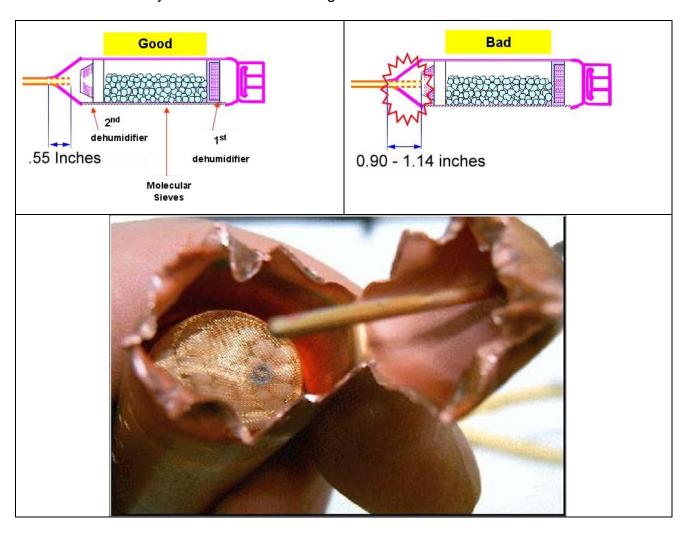
Figure 1

SYMPTOM: Low or No Cool Condition or Frost occurs on the outlet of the dryer.

Background: The Capillary Tube is inserted too far and touches dehumidifier material located inside of dryer. This blocks the refrigerant circulation.

Measure the Capillary tube distance (A-B in Figure 1); if it is less than 105mm (4.13 inches) the dryer must be replaced. Be sure to recharge the system after replacing dryer. If the capillary tube length is greater than 105mm (4.13 inches) the dryer does not need to be replaced.
